WL-TR-91-4032
DOT/FAA/CT-91/23
VOL II, Part 2

COMPOSITE FAILURE ANALYSIS HANDBOOK
VOL II - TECHNICAL HANDBOOK
PART 2 - ATLAS OF FRACTOGRAPHS

R.J. Kar
Northrop Corporation
One Northrop Avenue
Hawthorne, California 90250-3277

February 1992

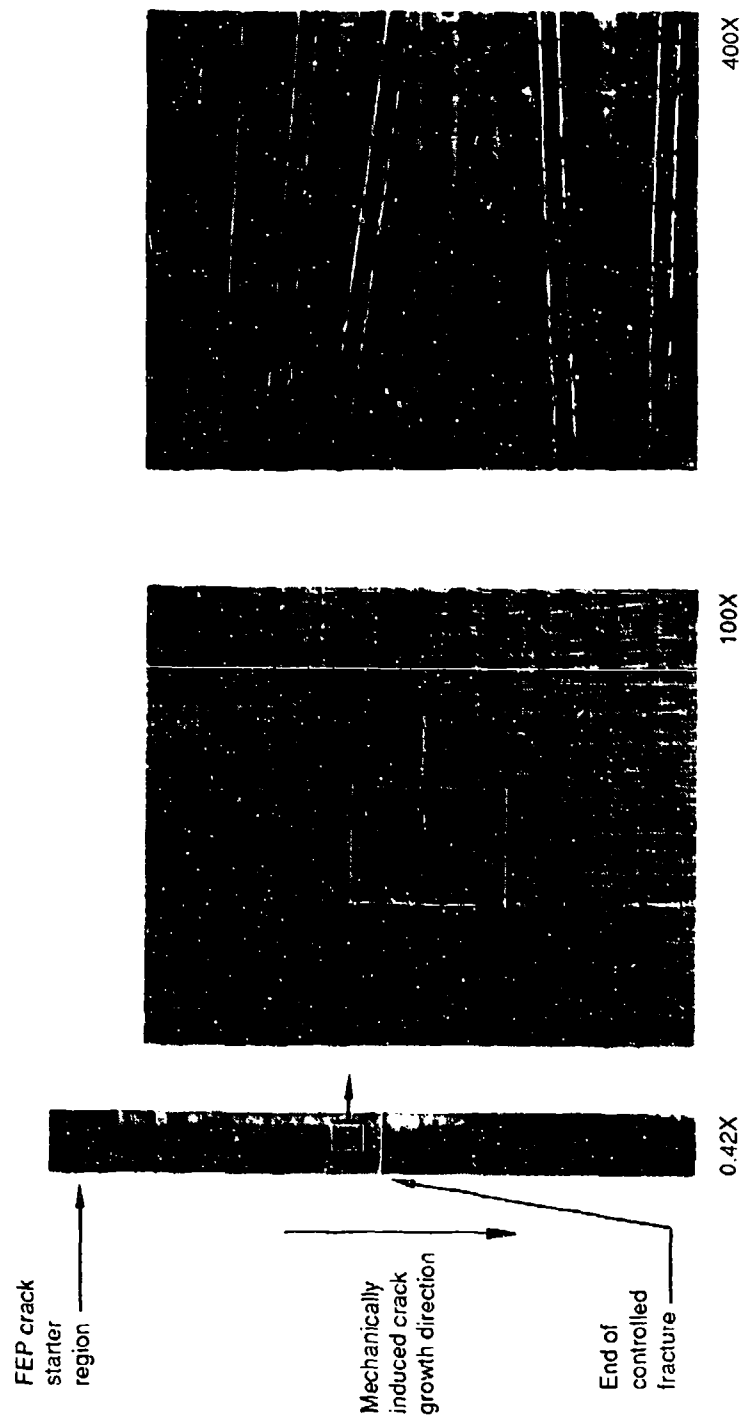
Figure 2-43. Optical Photomicrographs of Interlaminar Mode I Tension, 0/90 Fracture, Exposure to Humidity (160 F) After Test

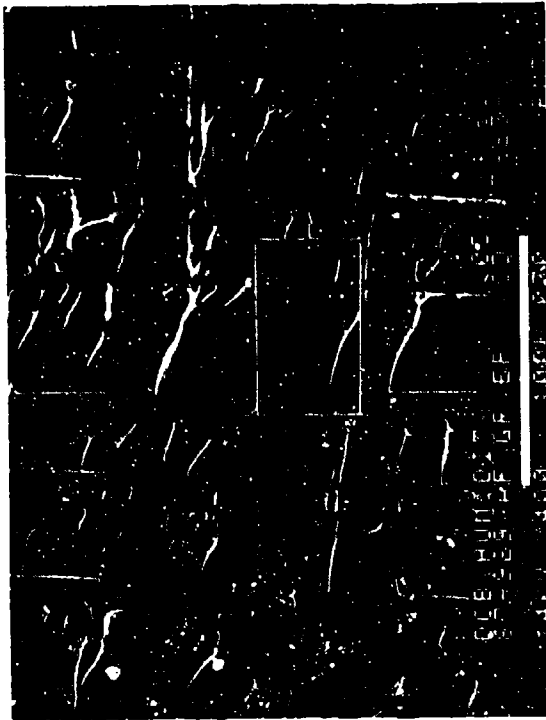
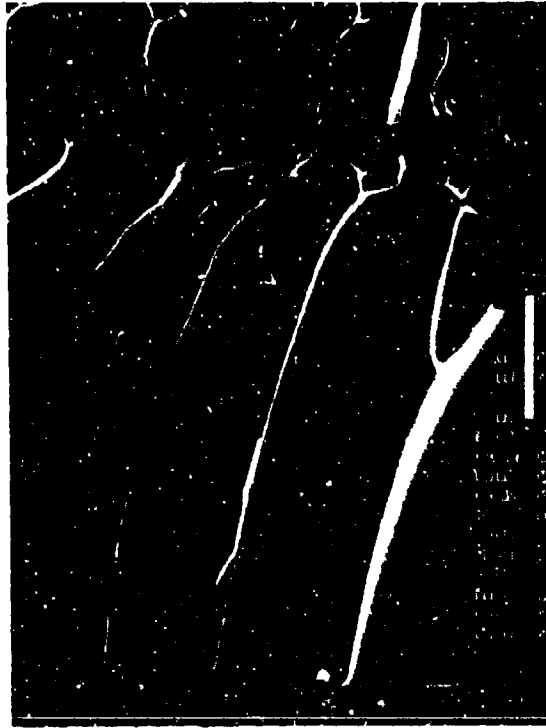
- M matrix fracture
- F fiber matrix separation
- R rivermarks

Mechanically induced
crack direction

Figure 2-44. SEM Fractographs of Interlaminar Mode I Tension, 0/90 Fracture, Exposure to Humidity (160 F) After Test

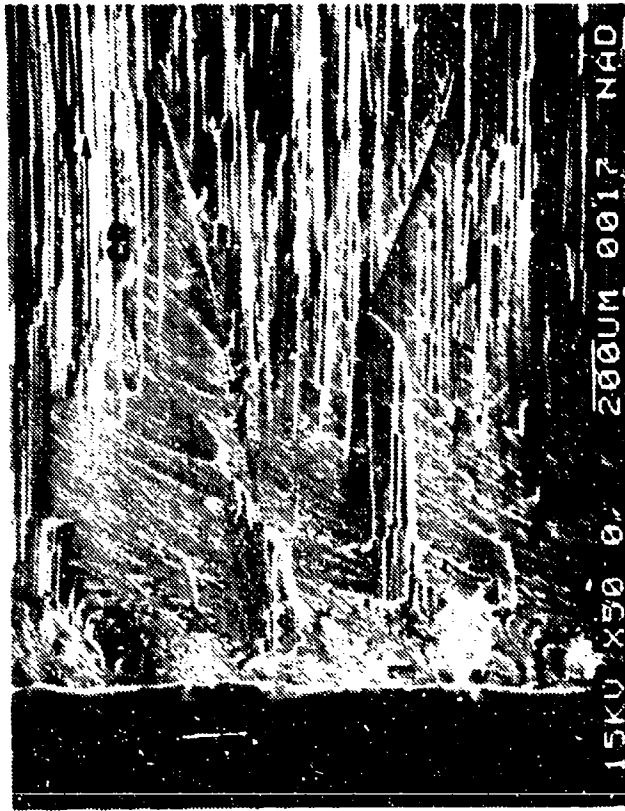
Figure 2-45. Optical and SEM Photographs of Mode I DCB Interlaminar Fracture in Undercured Gr/Ep - [0]_{24T}
 (a) Macro photograph showing Regions I, II, and III
 (b) Initiation in Region I Adjacent to Armalor (A)

CD = Crack-propagation direction

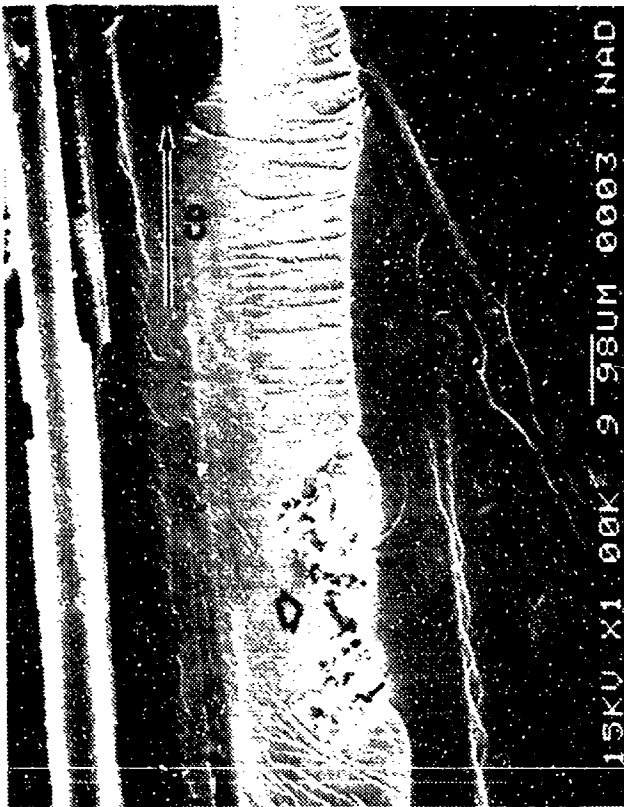
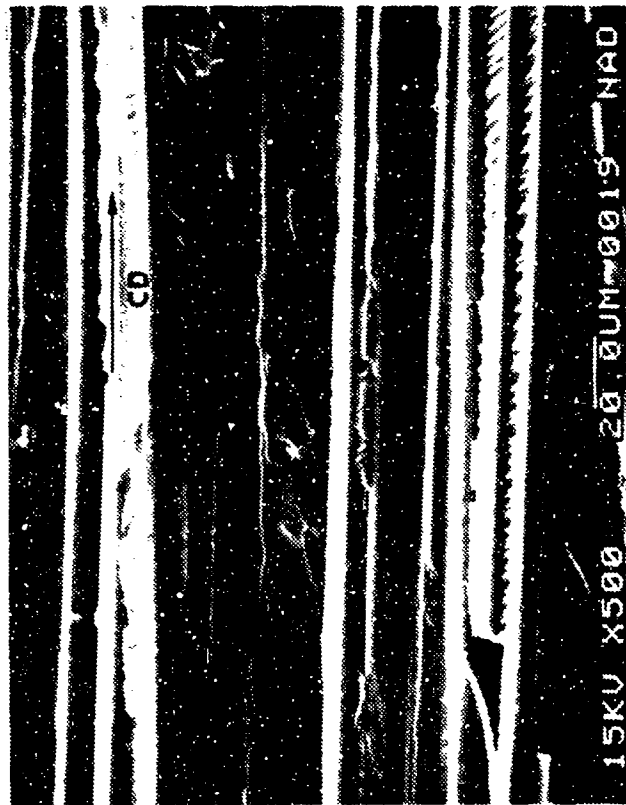
Figure 2-45. (Continued)
 (c) River Patterns Indicating Crack-Propagation Direction
 (d) Porosity (Arrows)

CD = Crack-propagation direction

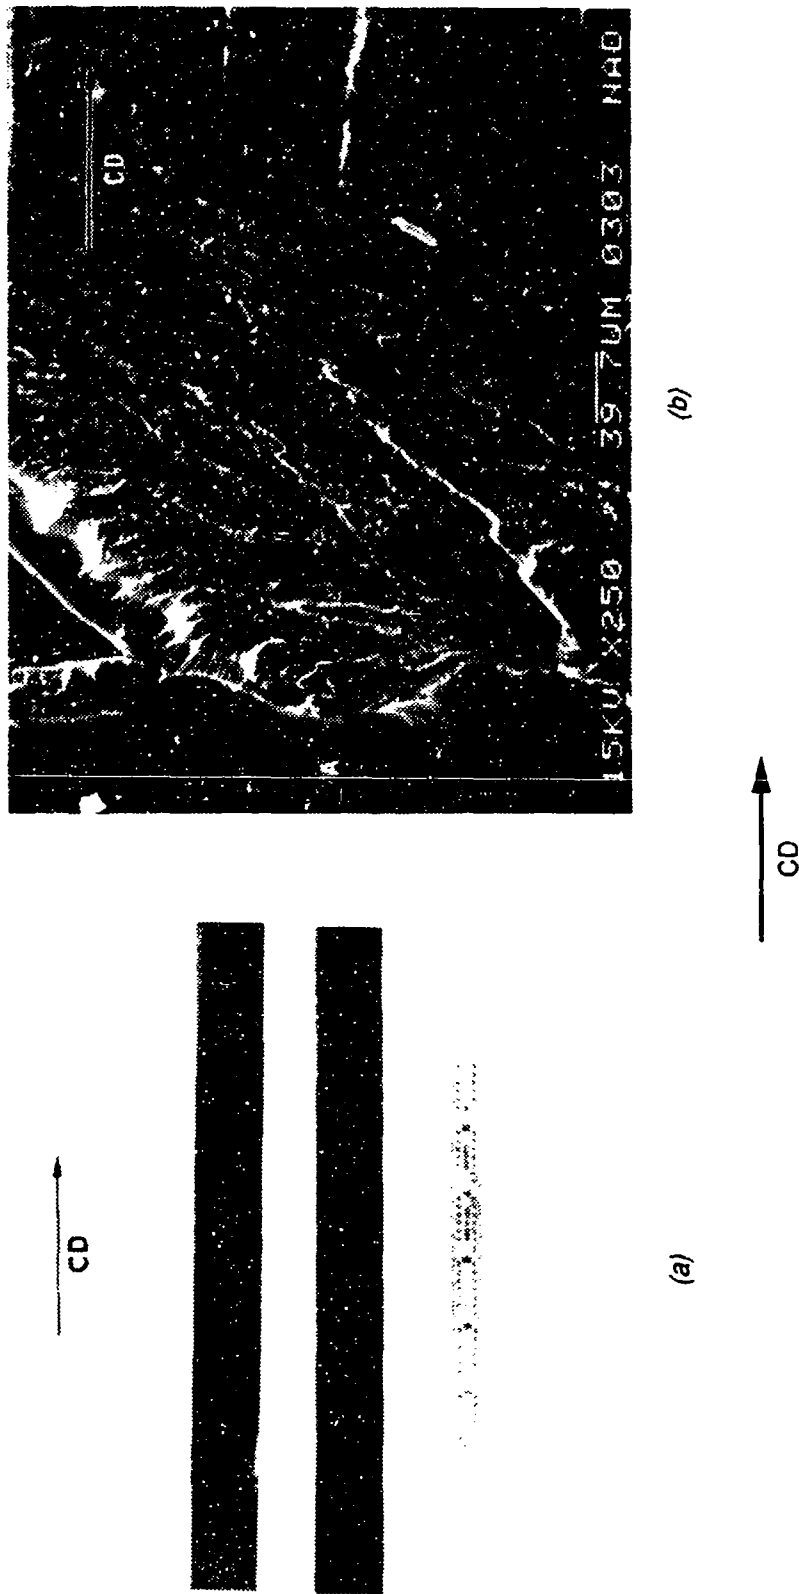
Figure 2-46. Optical and SEM Photographs of Mode I DCB Interlaminar Fracture in Undercured Gr/Ep - [+45/0/-45]_{4s}
 (a) Macro photograph Showing Radial Bands
 (b) Local Fracture Initiating in Region I

A = Armaton Insert

CD = Crack-propagation direction

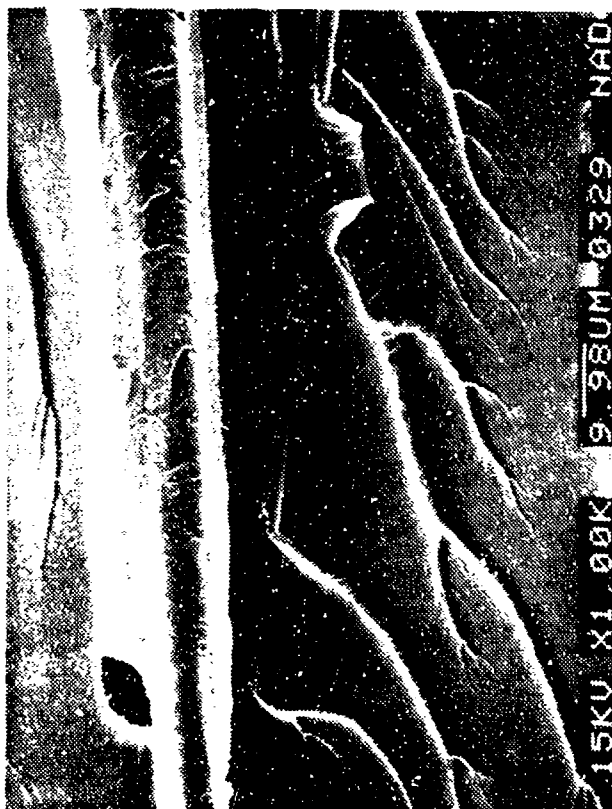
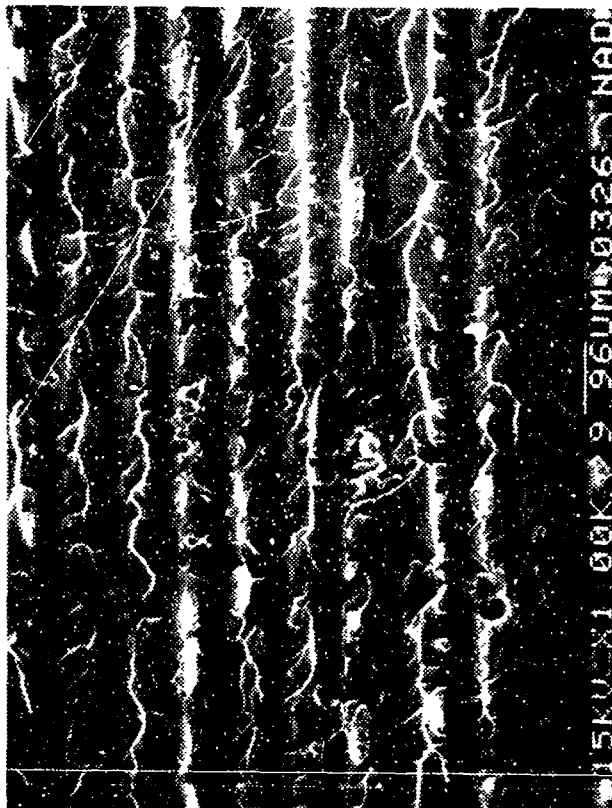
Figure 2-46. (Continued)
 (c) River Patterns in Fractured Epoxy
 (d) Local Porosity in Specimen

CD = Crack-propagation direction

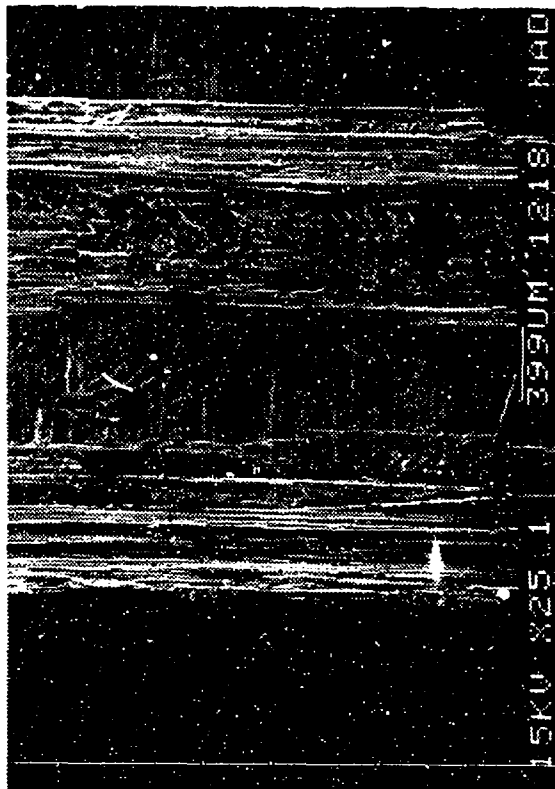
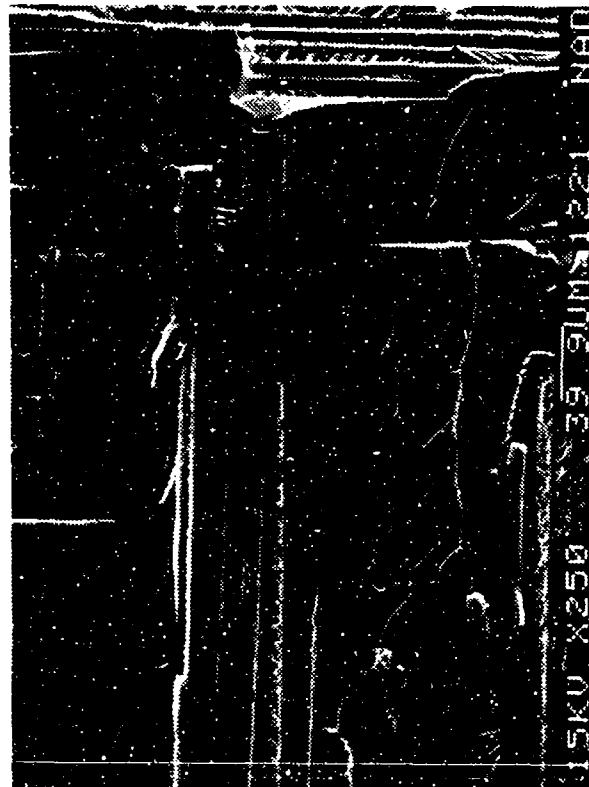
Figure 2-47. Optical and SEM Photographs of Mode I DCB Interlaminar Fracture in Undecured Gr/Ep - [0/90]_{as}
 (a) Macro photograph
 (b) Initiation in Precrack Region
 (c) River Patterns (R) in Region II

CD = Crack-propagation direction

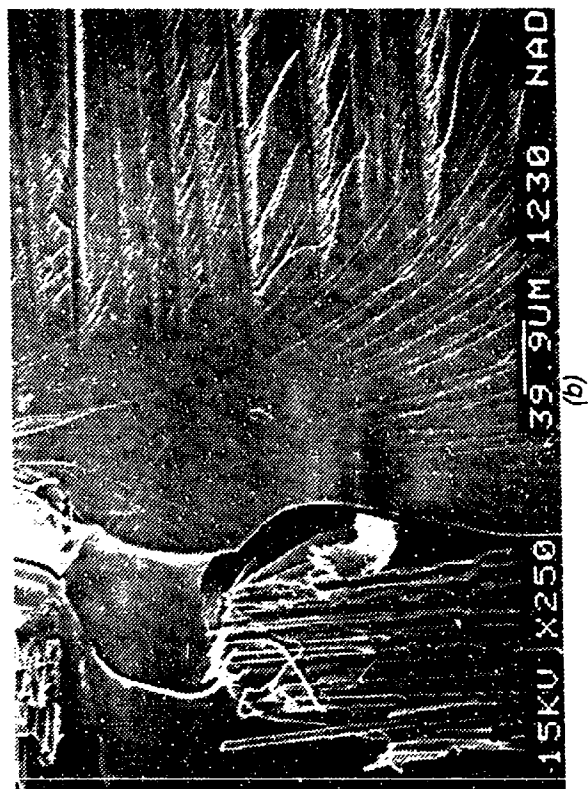
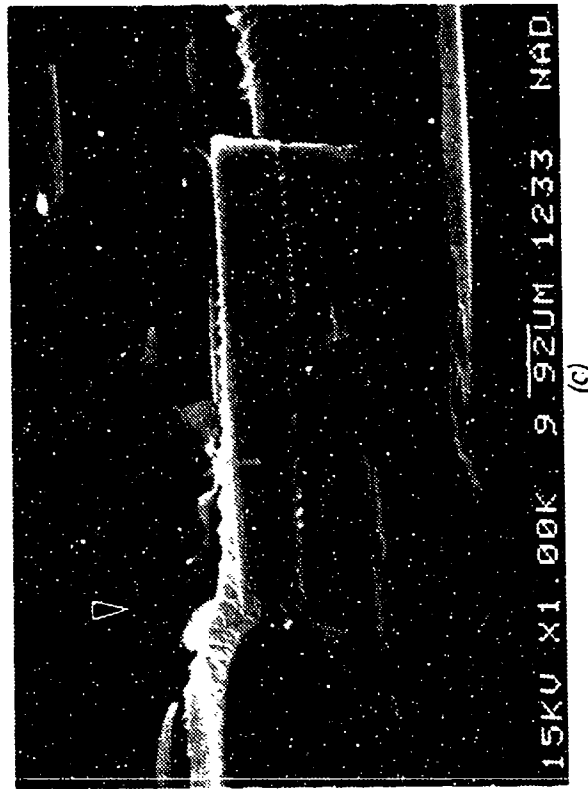
Figure 2-48. Optical and SEM Photographs of Mode I DCB Interlaminar Fracture in Overcured Gr/Ep - [0]_{24T}

(c) River Patterns (R) in Region II

CD = Crack-propagation direction

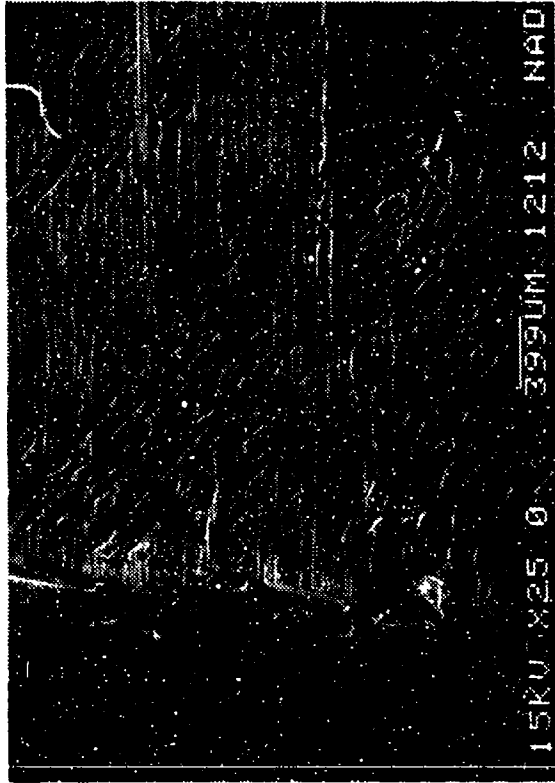
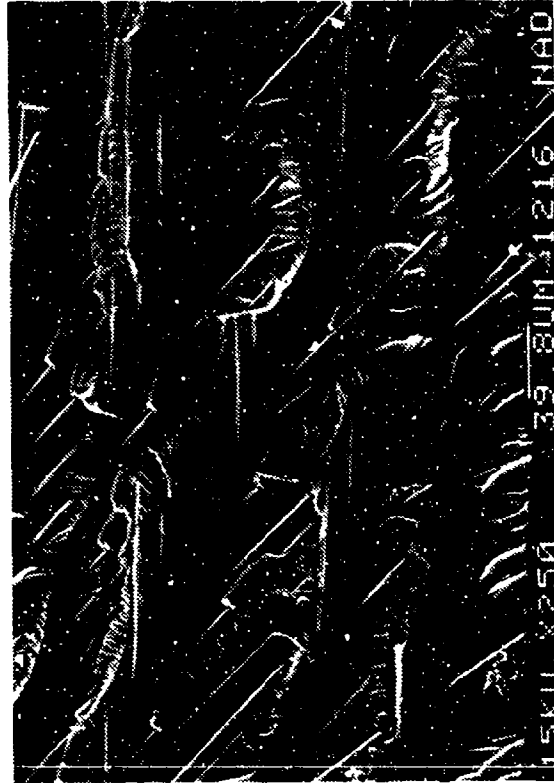
Figure 2-49. Optical and SEM Photographs of Mode I DCB Interlaminar Fracture in Overcured Gr/Ep - [+45/0/-45] _{4s}

(c) River Patterns (R) in Mode I Region

CD = Crack-propagation direction

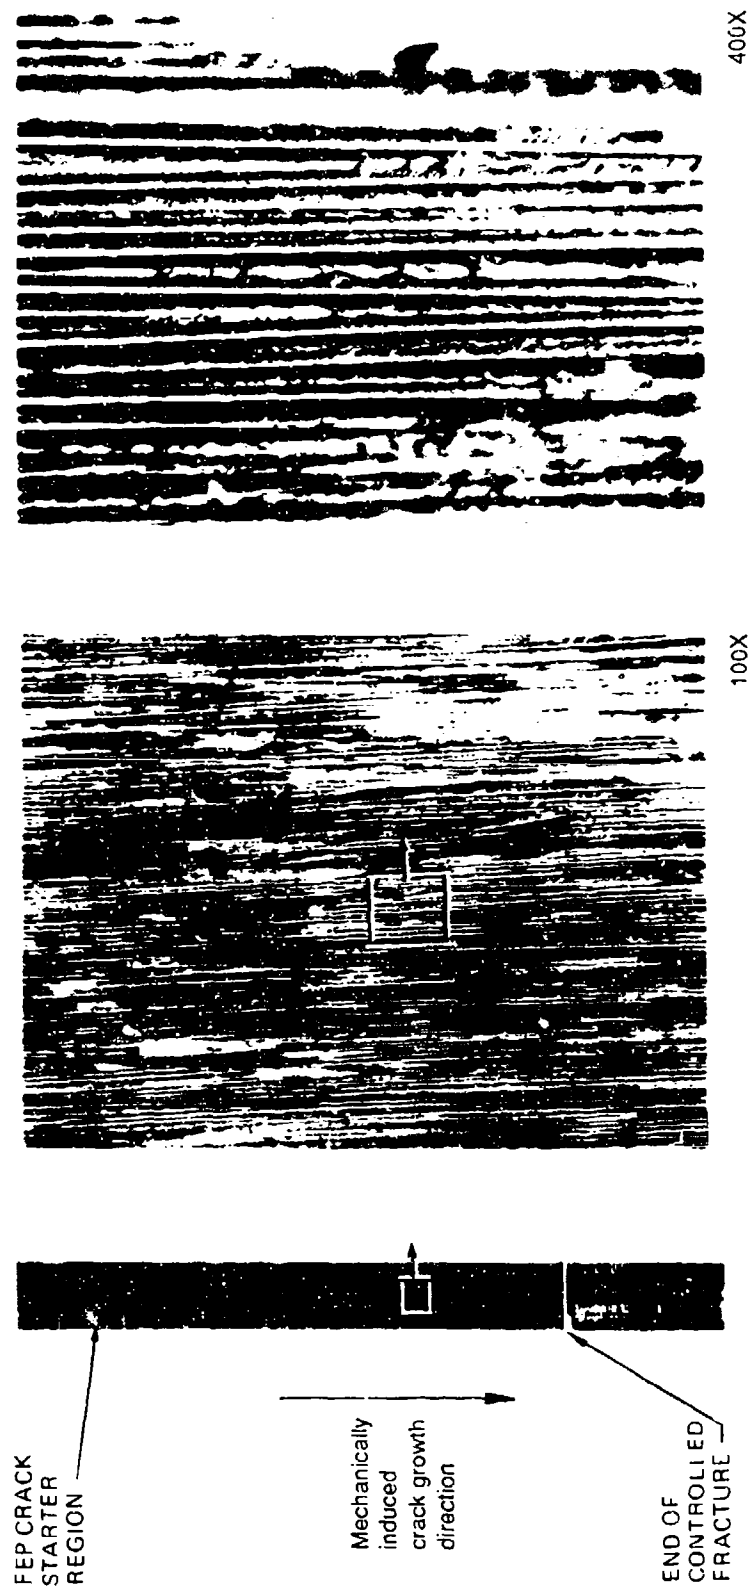
Figure 2-50. Optical Photomicrographs of Interlaminar Mode I Tension, 0/90 Fracture of Low Resin Content Specimen

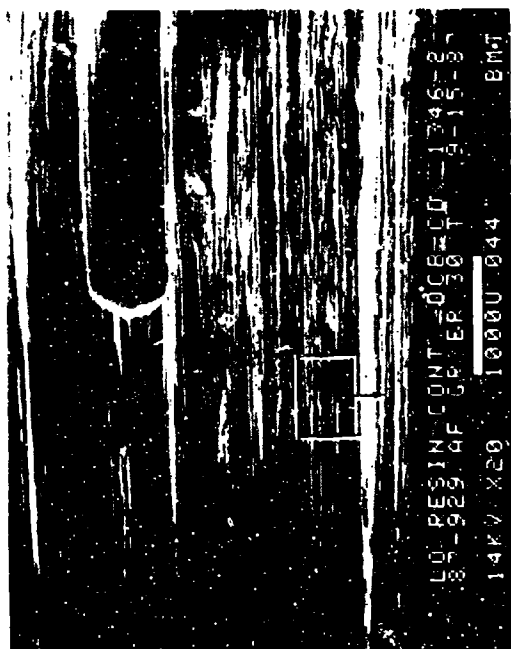
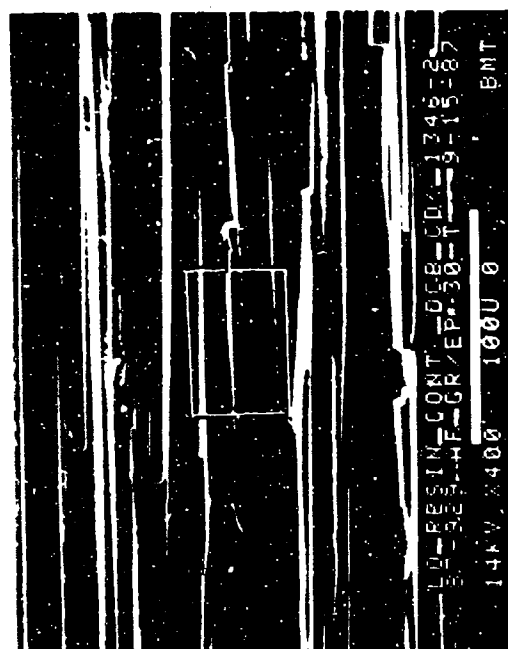
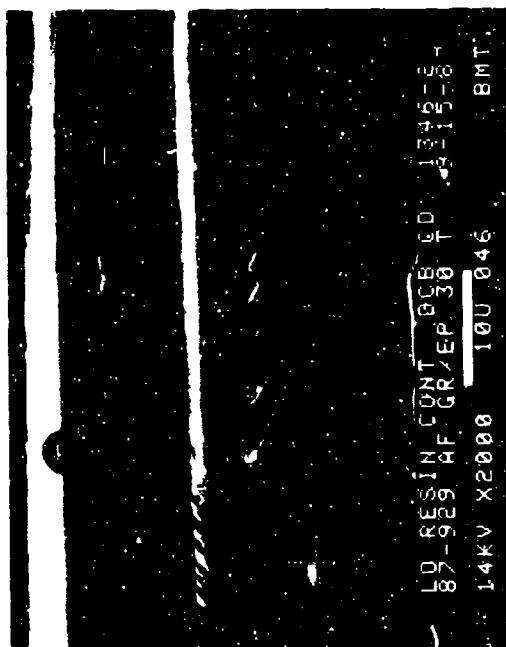
- M matrix fracture
- F fiber/matrix separation
- R rivermarks

Mechanically induced crack direction

Figure 2-51. SEM Fractographs of Interlaminar Mode I Tension, 0/90 Fracture of Low Resin Content Specimen

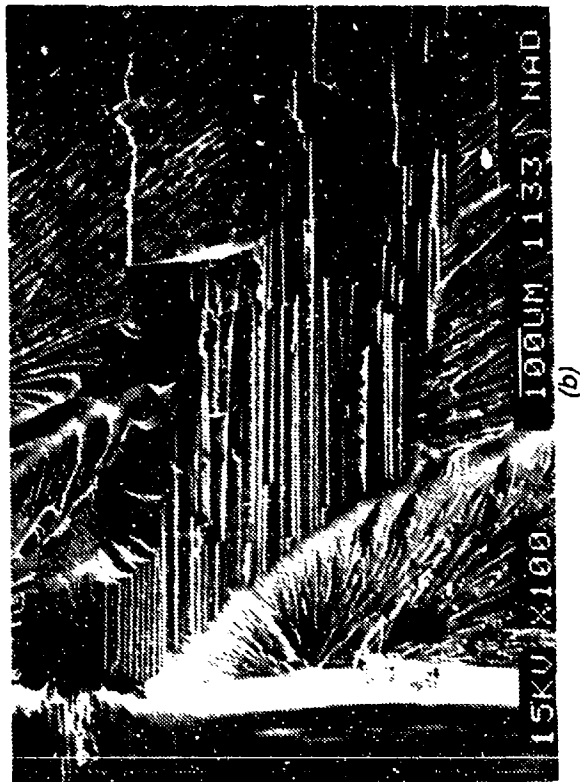
Figure 2-52. Optical and SEM Photographs of Mode I DCB Interlaminar Fracture in High Resin Content Gr/Ep - [0] ^{24T}

- (a) Macro photograph
- (b) Low Magnification SEM Photograph of Precrack Region
- (c) River Patterns in Mode I Region

CD = Crack propagation direction

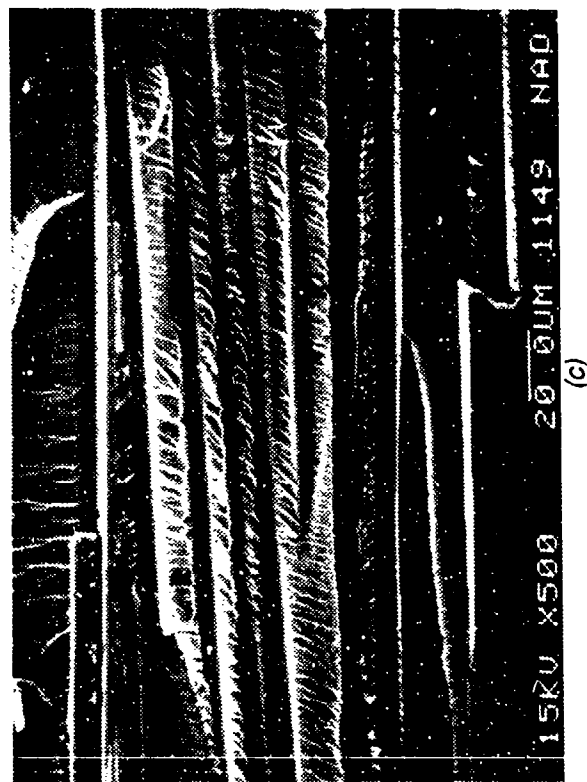
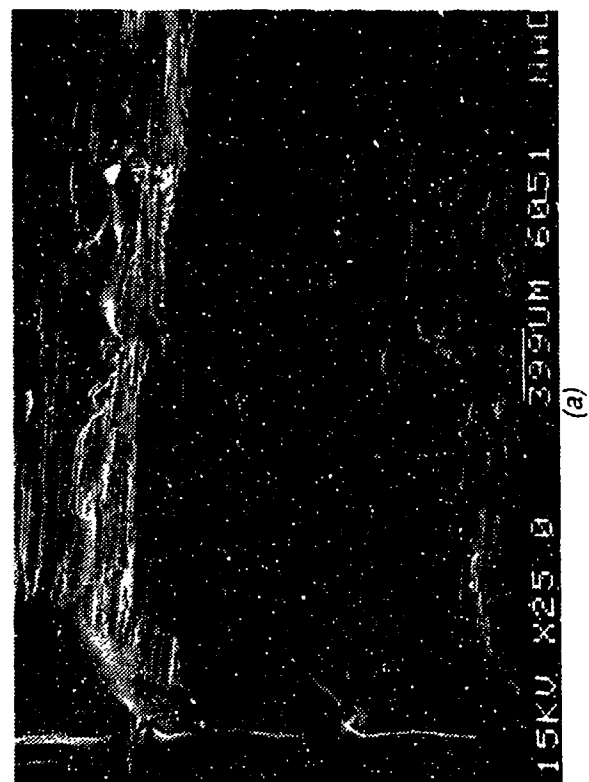
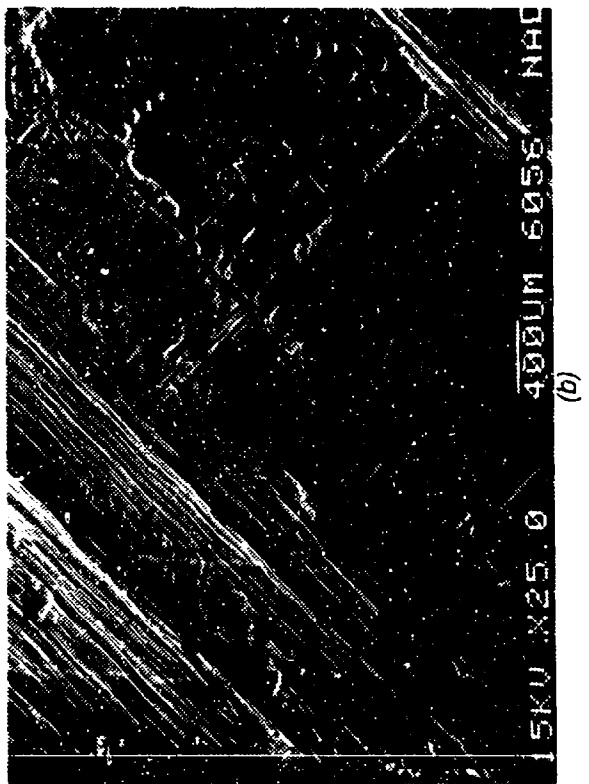
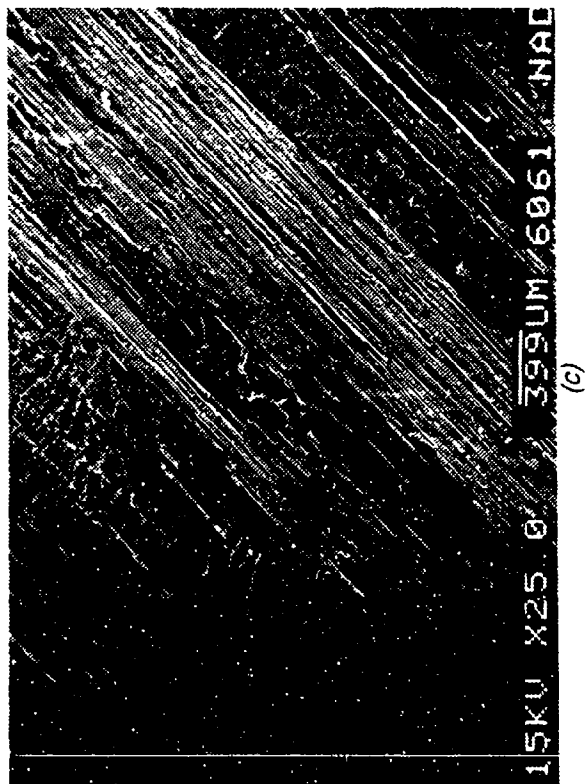
Figure 2-53. SEM Photographs of Mode I DCB Interlaminar Fracture in High Resin Content Gr/Ep, Conditioned 180 F Dry (a), (b), and (c) Initiation in Precrack Regions of [0]_{24T}, [+45/-45]_{4S}, and [+45/0/-45]_{6S} Coupons, Respectively

CD = Crack-propagation direction

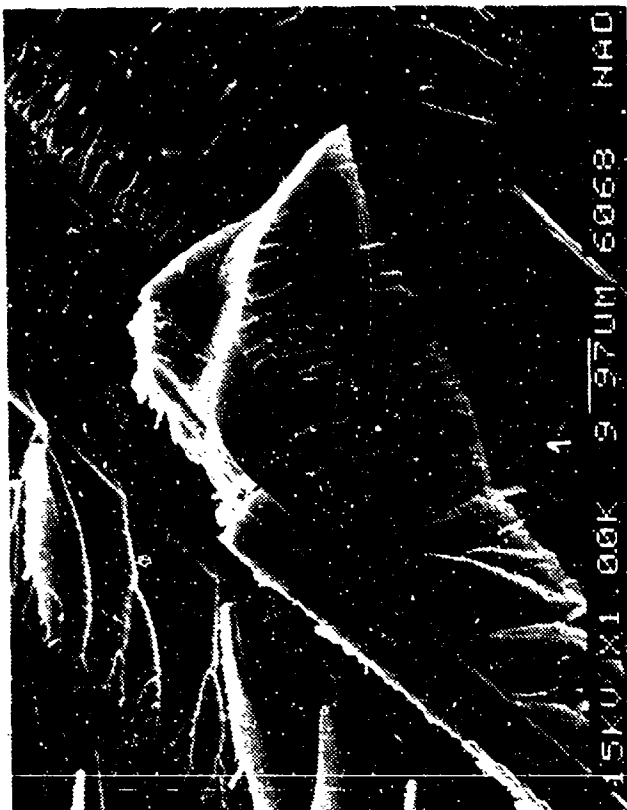
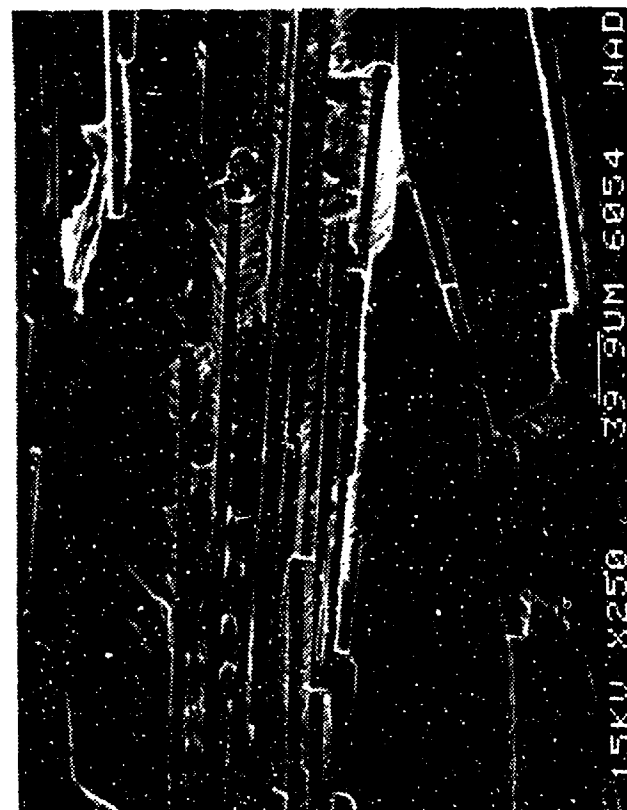
Figure 2-54. SEM Photographs of Mode I DCB Interlaminar Fracture Details in High Resin Content Gr/Ep, Conditioned 180 F Dry After Test

CD = Crack-propagation direction
R = River patterns

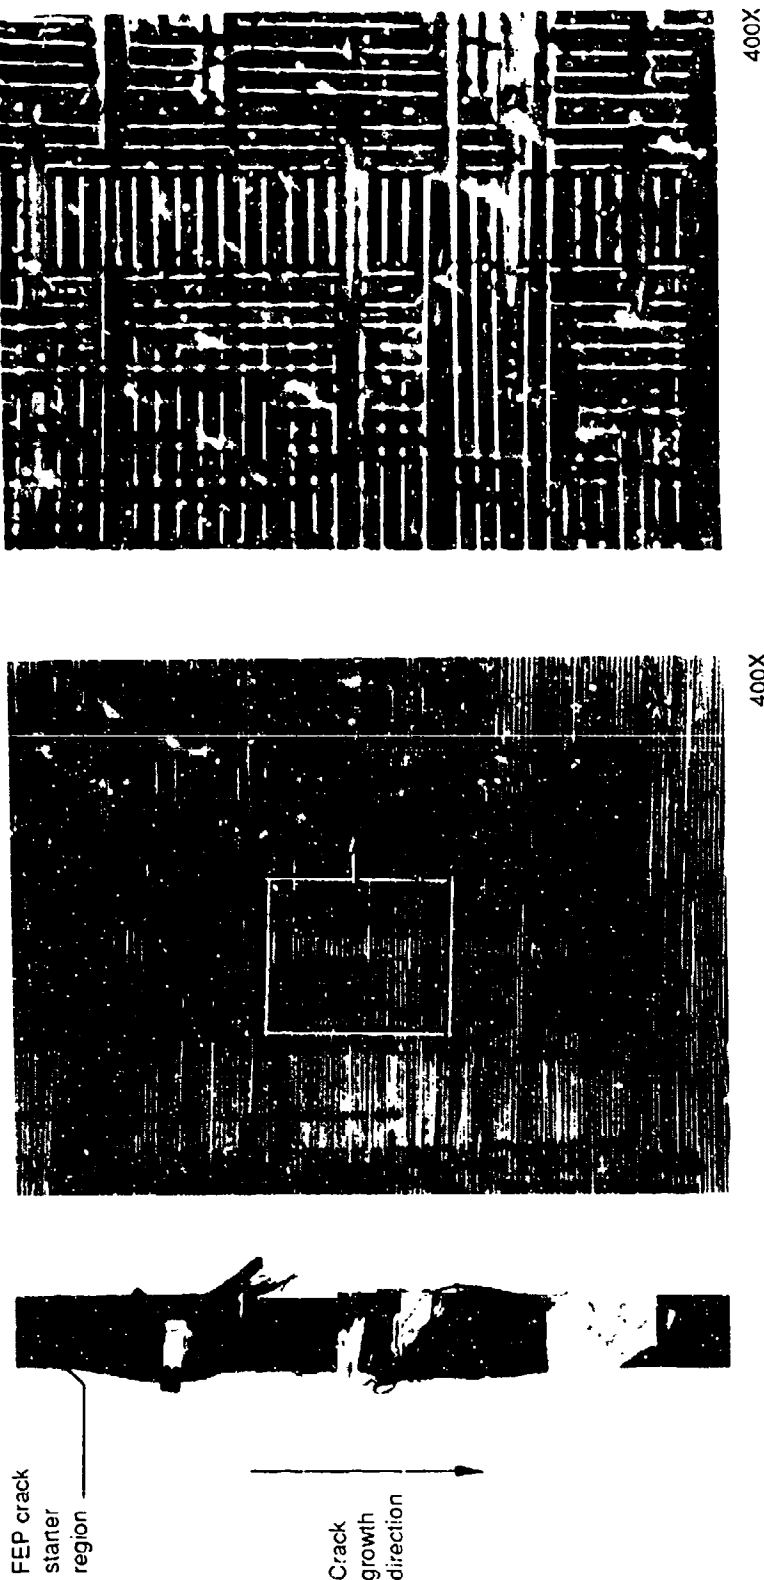
Figure 2-56. Optical Photomicrographs of Interlaminar Mode I Tension, 0/90 Fracture, 2000 F Exposure for 5 Minutes After Test

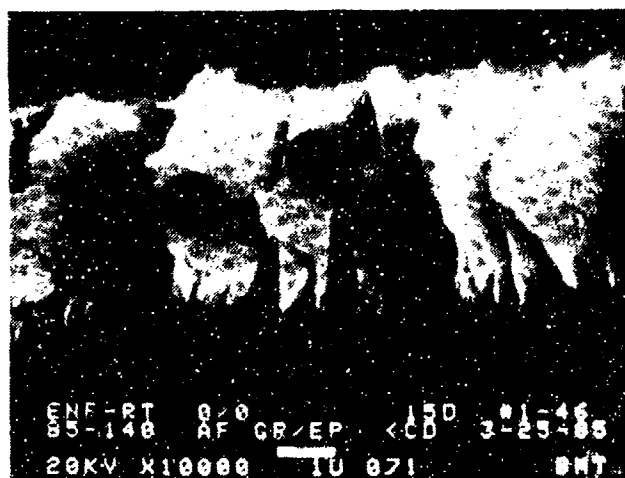
Fracture type	Interlaminar mode II shear
Ply layup	[0] 24
Test type	ENF
• Test conditions	21°C, dry
• Fracture between	0/0 plies
Material	Hercules 3501-6/177° C cure AS4 fibers

Mechanically induced crack direction

- F Fiber matrix separation
- H Hackles
- R River markings
- T Textured microflow

Figure 2-60. SEM Photographs of Interlaminar Mode II Shear, 0/0 Fracture, 70 F/Dry

Table 2-2 shows the test matrix for the end-notched flexural (ENF) test type. Figure 2-58 shows the ENF test geometry. The fractographs from the interlaminar shear testing are shown in Figures 2-59 through 2-99. These figures are arranged in the same order that the corresponding tests are listed in Table 2-2.

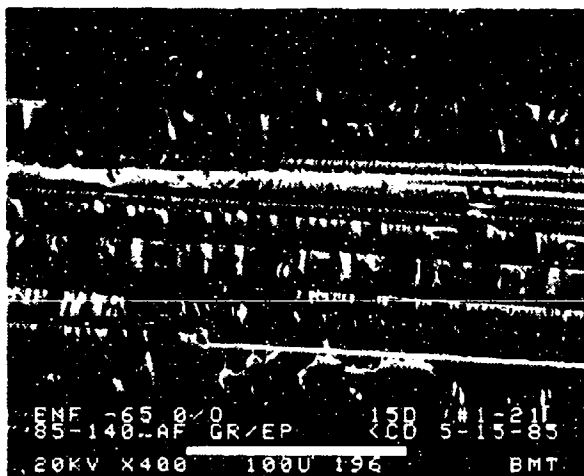
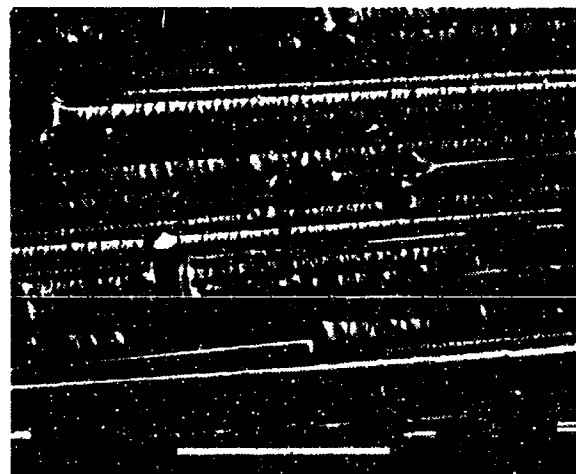
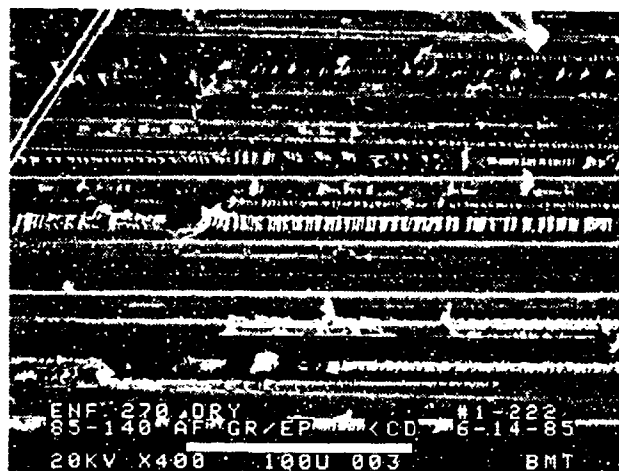
Fracture type	Interlaminar mode II shear
Ply layup	[0] 24
Test type	ENF
• Test conditions	Dry
• Fracture between	0/0 plies
Material	Hercules 3501-6/177° C cure AS4 fibers

Mechanically induced crack direction

-65°F, dry

70°F, dry

270°F, dry

Figure 2-62. SEM Photographs of Interlaminar Mode II Shear, 0/0 Fracture, -65, 70, and 270 F/Dry (400X)

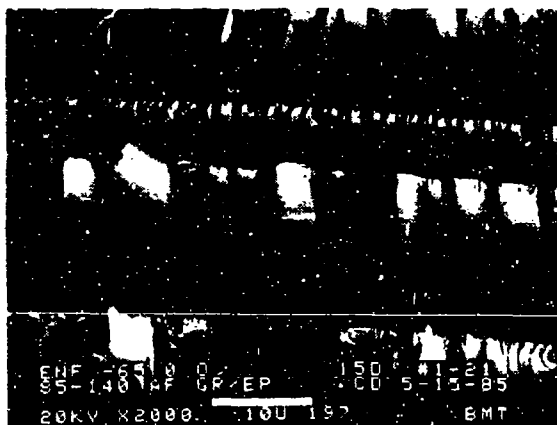
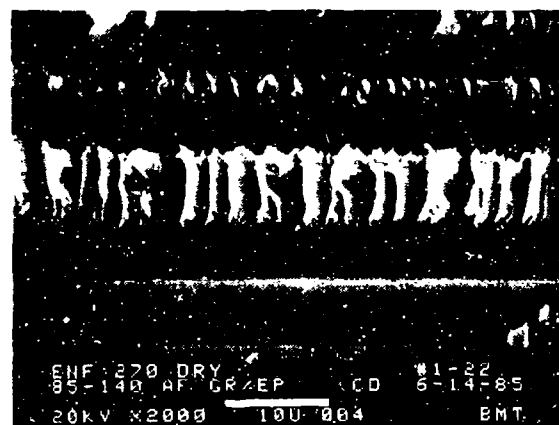
Fracture type	Interlaminar mode II shear
Ply layup	[0] 24
Test type	ENF
• Test conditions	Dry
• Fracture between	0/0 plies
Material	Hercules 3501-6/177°C cure AS4 fibers

-65°F, dry

70°F, dry

270°F, dry

Figure 2-63. SEM Photographs of Interlaminar Mode II Shear, 0/0 Fracture, -65, 70, and 270 F/Dry (2000X)

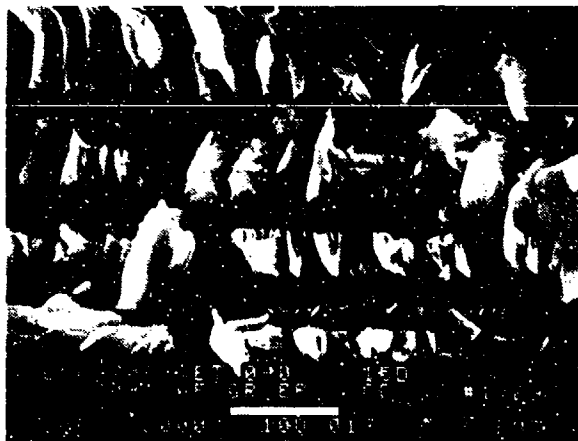
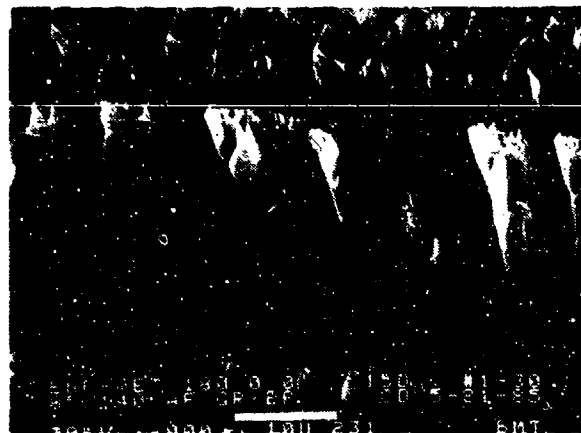
Fracture type	Interlaminar mode II shear
Ply layup	[0] 24
Test type	ENF
• Test conditions	Wet
• Fracture between	0/0 plies
Material	Hercules 3501-6/177° C cure AS4 fibers

70°F, wet

180°F, wet

Figure 2-65. SEM Photographs of Interlaminar Mode II Shear, 0/0 Fracture, 70 and 180 F/Wet

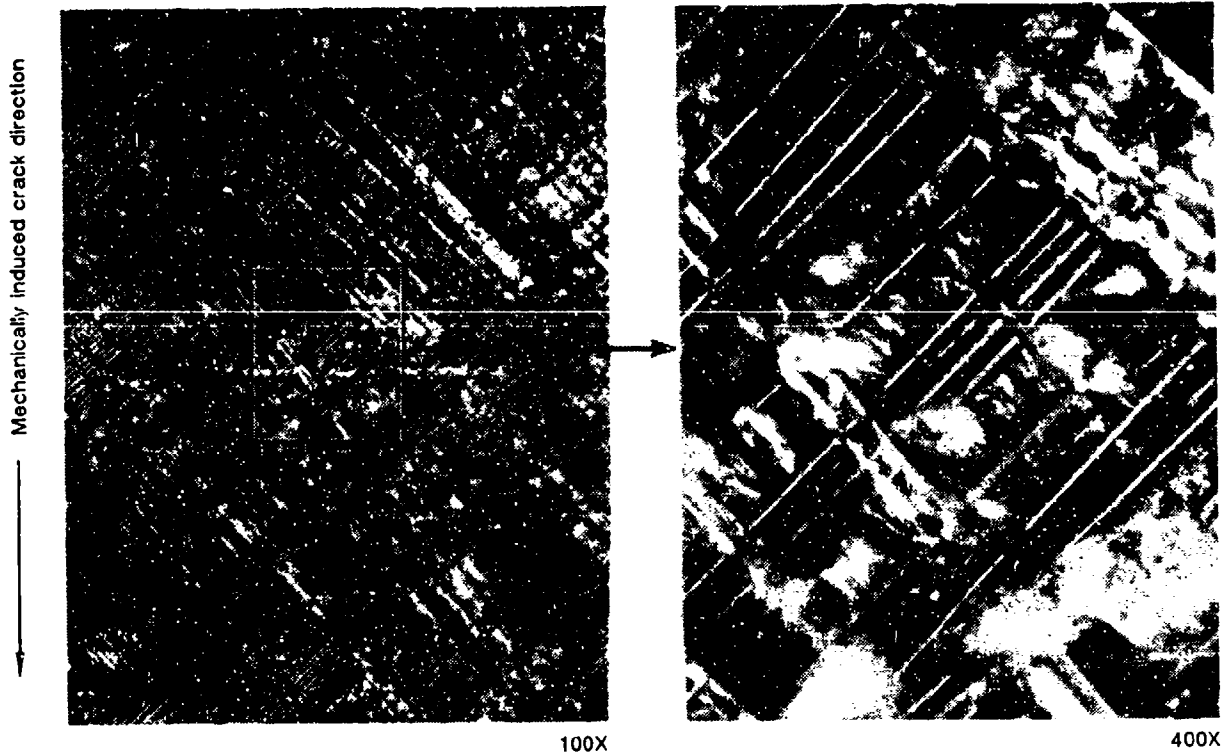
Fracture type	Interlaminar mode II shear
Ply layup	[+45/-45] 12S
Test type	ENF
• Test conditions	21°C, dry
• Fracture between	+45/-45 plies
Material	Hercules 3501-6/177°C cure AS4 fibers

Figure 2-66. Photographs of Interlaminar Mode II Shear, +45/-45 Fracture, 70 F/Dry

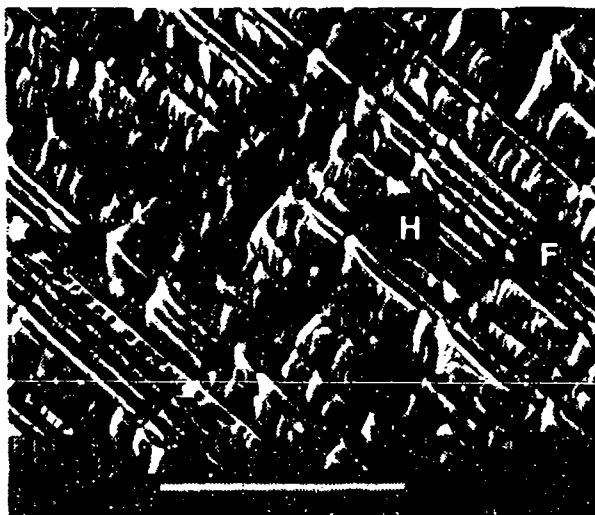
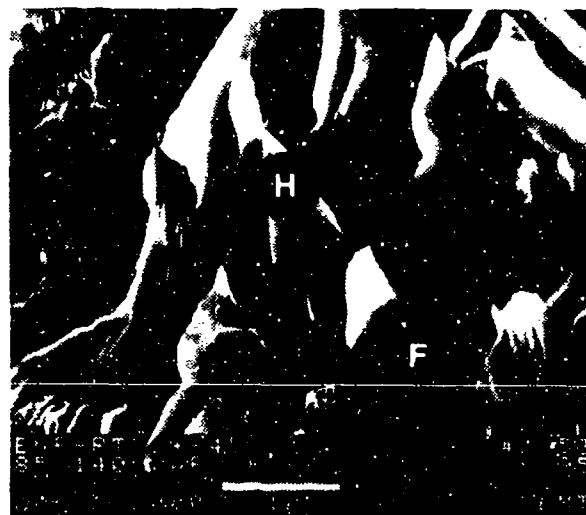
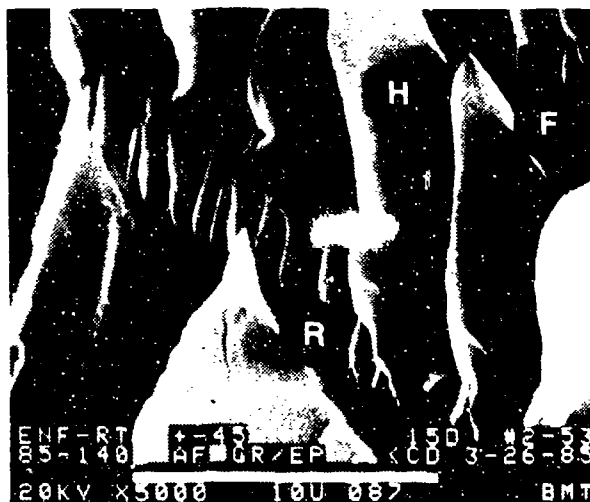
Fracture type	Interlaminar mode II shear
Ply layup	[+45/-45] 12S
Test type	ENF
• Test conditions	21°C, dry
• Fracture between	+45/-45 plies
Material	Hercules 3501-6/177°C cure AS4 fibers

Mechanically induced crack direction

- F Fiber matrix separation
- H Hackles
- R River markings

Figure 2-67. SEM Photographs of Interlaminar Mode II Shear, +45/-45 Fracture, 70 F/Dry

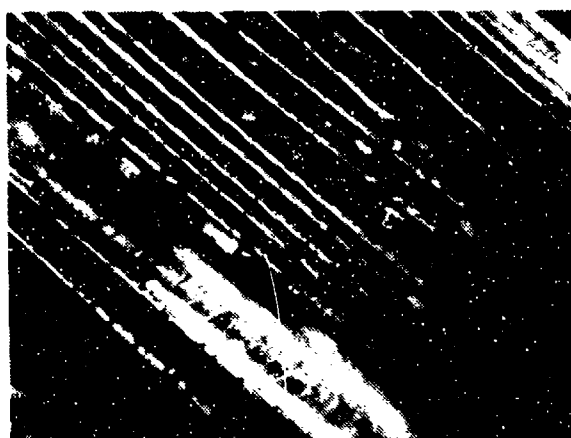
Fracture type	Interlaminar mode II shear
Ply layup	[+45/-45] 12S
Test type	ENF
• Test conditions	Dry
• Fracture between	+45/-45 plies
Material	Hercules 3501-6/177°C cure AS4 fibers

-65°F, dry

70°F, dry

270°F, dry

Figure 2-68. Photographs of Interlaminar Mode II Shear, +45/-45 Fracture, -65, 70 and 270 F/Dry

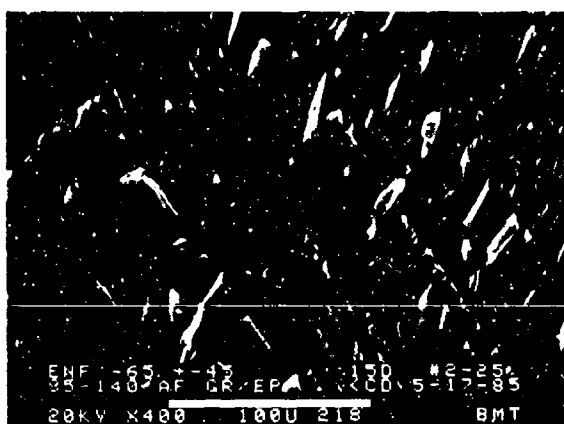
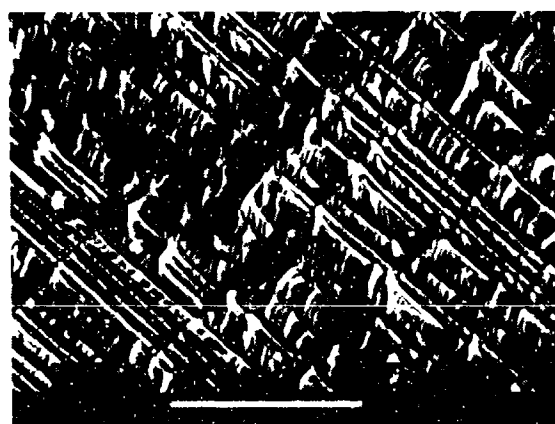
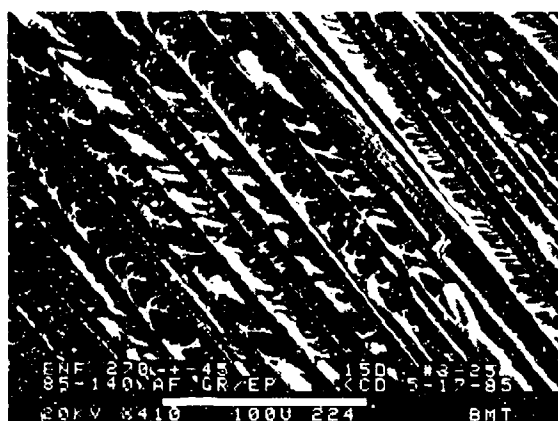
Fracture type	Interlaminar mode II shear
Ply layup	[+45, -45] ₁₂ S
Test type	ENF
• Test conditions	Dry
• Fracture between	+45/-45 plies
Material	Hercules 3501-6/177°C cure AS4 fibers

-65°F, dry

70°F, dry

270°F, dry

Figure 2-69. SEM Photographs of Interlaminar Mode II Shear, +45/-45 Fracture, -65, 70 and 270 F/Dry (400X)

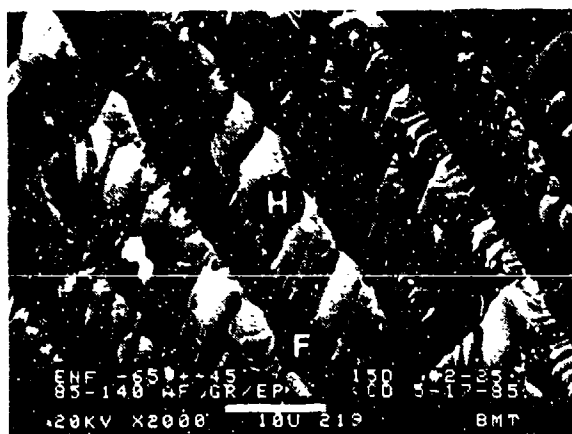
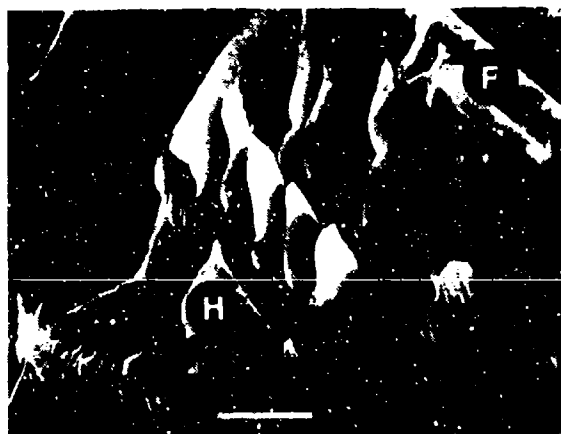
Fracture type	Interlaminar mode II shear
Ply layup	[+45/-45] 12S
Test type	ENF
• Test conditions	Dry
• Fracture between	+45/-45 plies
Material	Hercules 3501-6/177°C cure AS4 fibers

F Fiber matrix separation
H Hackles

-65°F, dry

70°F, dry

Figure 2-70. SEM Photographs of Interlaminar Mode II Shear, +45/-45 Fracture, -65, 70 and 270 F/Dry (2000X)

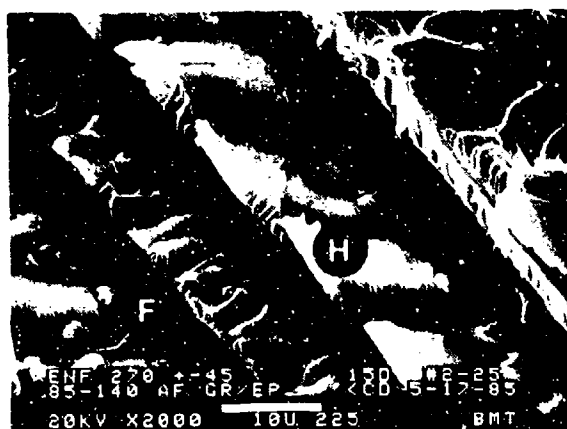
← Mechanically Induced crack direction

270°F, dry
